KL30 TURBO-TOC®

APPLICATION BULLETIN KL30 Solves Turbine Gland Steam Seal Leaks

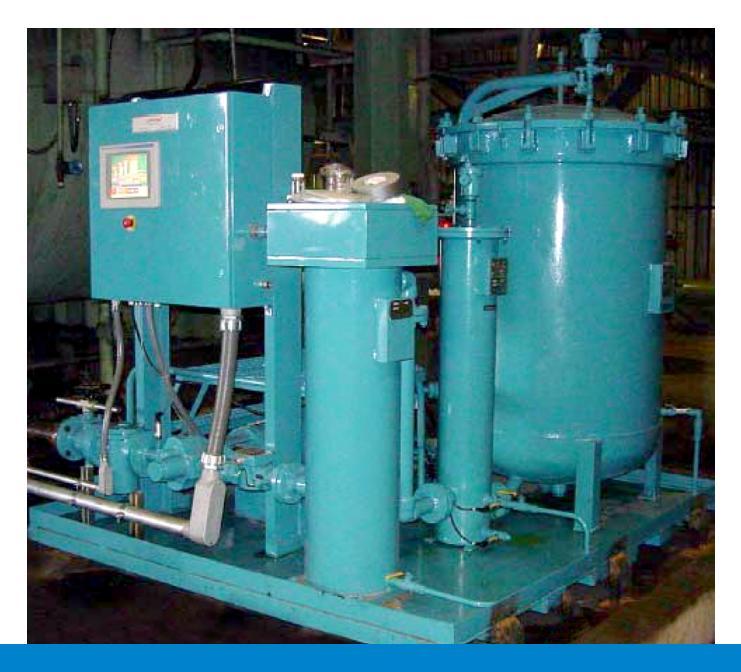
To solve the problem, a TURBO-TOC[®] KL30 was purchased and put into service in March 2006. Oil analysis reports have revealed the KL30 is exceeding the performance criteria specified by the customer. Over a 3-month period, the KL30 has removed 1,076 gallons of water from the turbine oil.
